NASA TM X-2271

REACTOR IRRADIATION OF
THERMIONIC SHEATH INSULATORS

by John T. Mayer

Lewis Research Center

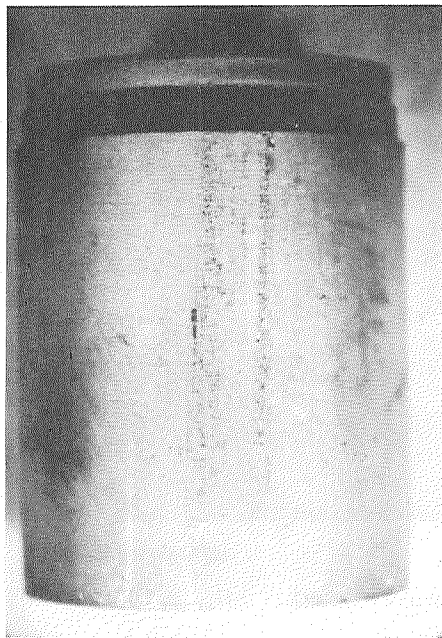
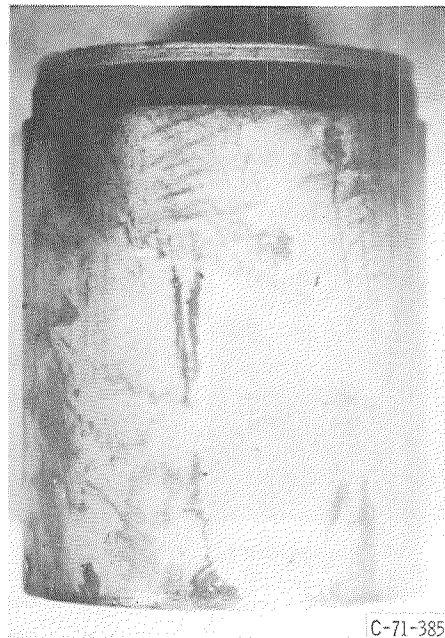
(a) BeO specimen 1 (Canister II).

(b) BeO specimen 2 (Canister I).

(c) Al₂O₃ specimen 4 (Canister II).

(d) Al₂O₃ specimen 5 (Canister I).

Figure 6. - General appearance of trilayers after irradiation.

Figure 6 shows the four trilayers after removal from the canisters. The appearance of the niobium is similar to that before irradiation except for sample 2, which looks somewhat corroded. The visible part of the insulator darkened noticeably for samples 1 and 4 (compare with fig. 1). The insulator defect on sample 1 (visible at the

upper left in fig. 6) was there before irradiation.

Each of the two BeO samples had about six cracks in the inner niobium at the stepped end. Some of these can be seen in figure 6. It is possible that thermal expansion of the canister and cap, or disassembly operations, caused these. None of these cracks extend beyond the visible portion of the BeO, and no such cracks were observed at any other location.
